# County Route 18 - Milepoint 14.6

Data Capture & Analysis Report

DW-RPT-RDW-2026-0028

Finding DW-FND-RDW146-001

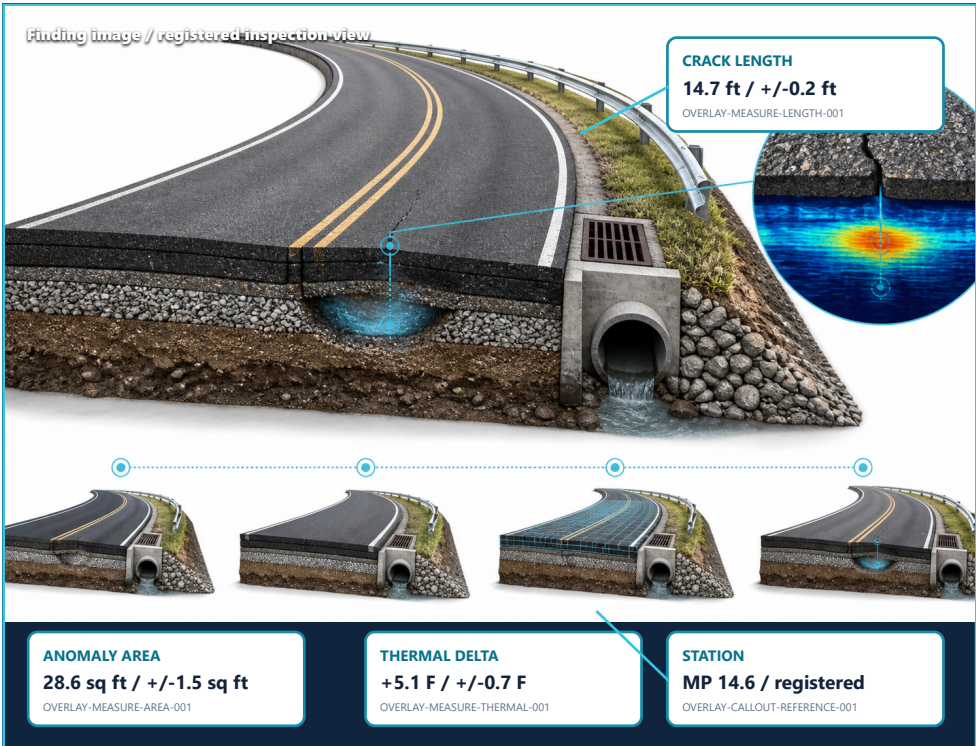
## Surface crack with subsurface moisture indication

A longitudinal surface crack and correlated subsurface thermal anomaly were identified near Milepoint 14.6.

County Route 18 / MP 14.6 / Eastbound wheel path

RGB-RDW146-018 / IR-RDW146-009

Repeat thermal capture and perform pavement sounding or GPR before drainage and core review.
