# Structure TX-884 - Phase B

Data Capture & Analysis Report

DW-RPT-ETR-2026-0031

Finding DW-FND-TX884-001

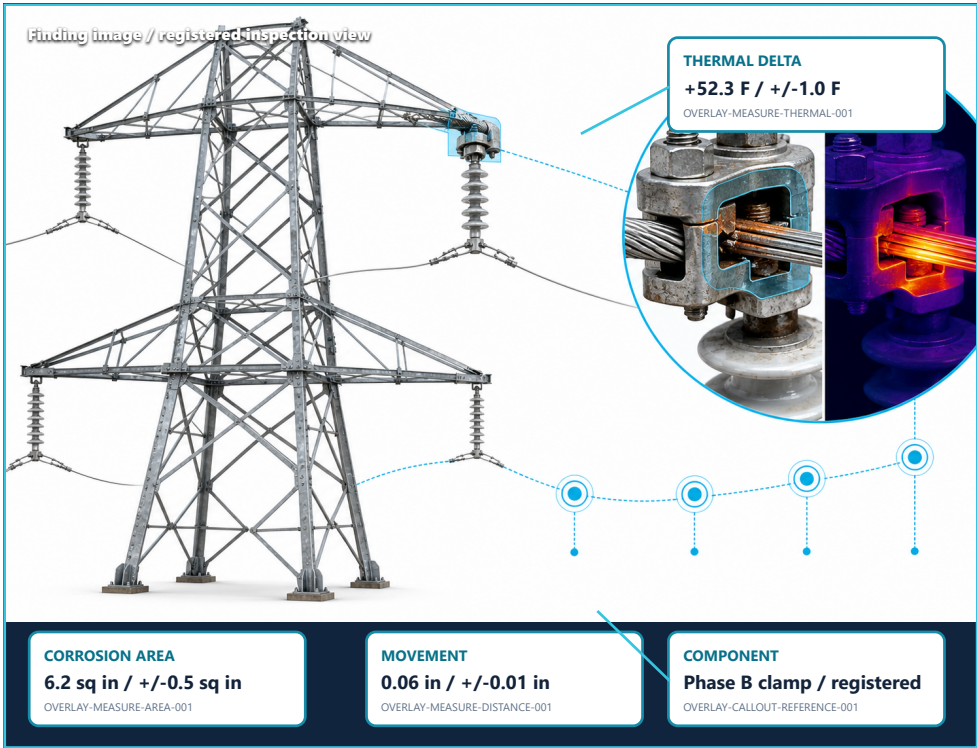
IR-TX884-031 / RGB-TX884-017

## Elevated connection temperature with visible corrosion

A localized thermal rise and corrosion were identified at the Phase B conductor-clamp connection.

| <p>Status</p> <p>Analyzing</p> | <p>Disposition</p> <p>Further Investigation Required</p> | <p>Priority</p> <p>P0 - Critical</p> | <p>Confidence</p> <p>High</p> |

Initiate utility review, confirm under representative load, and perform a qualified de-energized connection inspection.
