# North Municipal Tank - Seam V-08

Data Capture & Analysis Report

DW-RPT-WTR-2026-0009

## Coating failure with active corrosion at shell seam

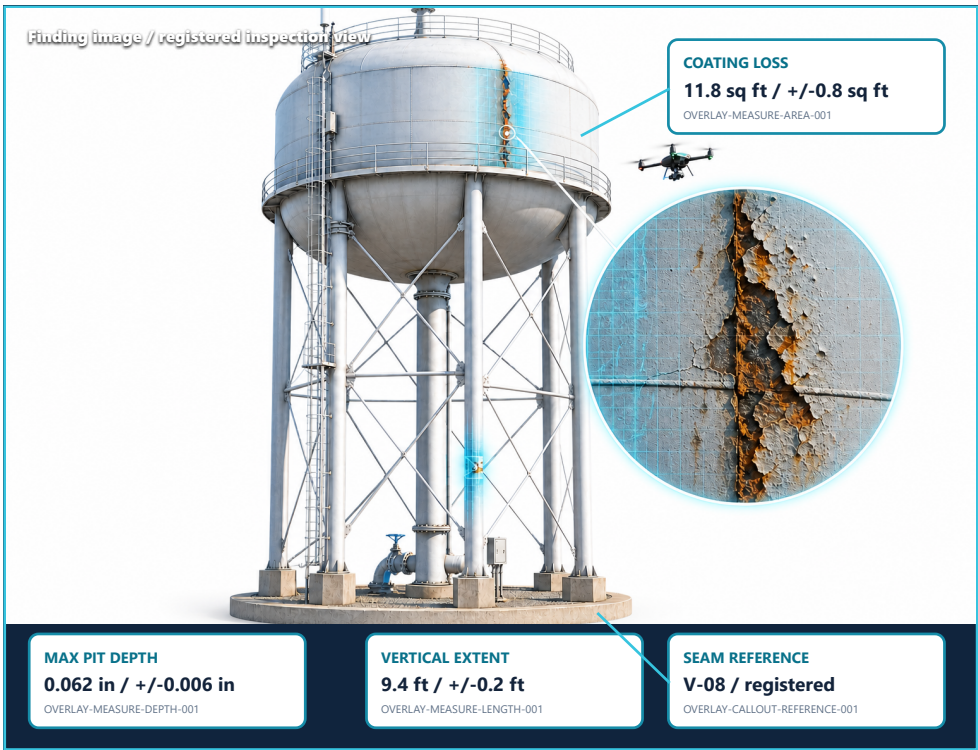
Coating delamination and corrosion were identified along vertical shell seam V-08 and an adjacent support connection.

North Municipal Tank / Upper shell / Seam V-08

Obtain coating-specialist review, ultrasonic thickness testing, and a bounded repair-scope determination.
