# River Crossing Bridge - Pier 6

Data Capture & Analysis Report

DW-RPT-BRG-2026-0042

Finding DW-FND-PIER6-001

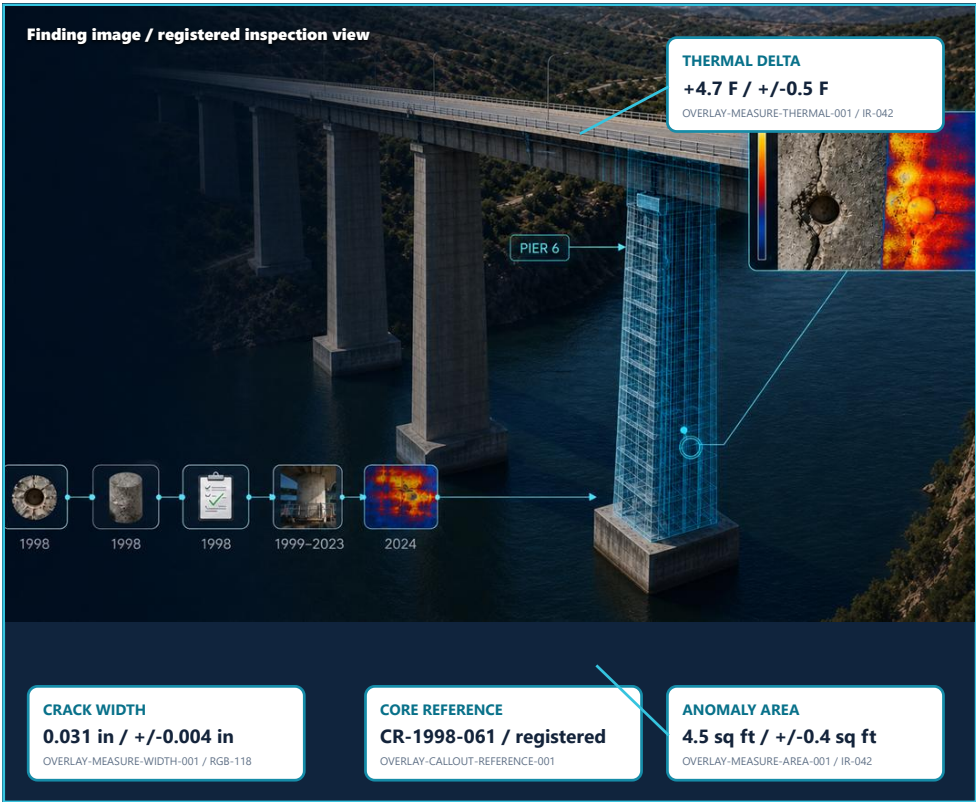
## Thermal anomaly consistent with possible subsurface moisture

Thermal contrast and an adjacent visible surface crack were identified near the historical core-sample zone on the north face of Pier 6.

Pier 6 / North face / Historical core zone

Further Investigation  
Required

P1 - High

Repeat controlled thermal capture; perform calibrated crack measurement; verify moisture using suitable nondestructive testing; compare historical inspections; submit for qualified engineering determination.
