# Tower ASR-1004723 - Sector B

Data Capture & Analysis Report

DW-RPT-TEL-2026-0014

Finding DW-FND-ASR1004723-001

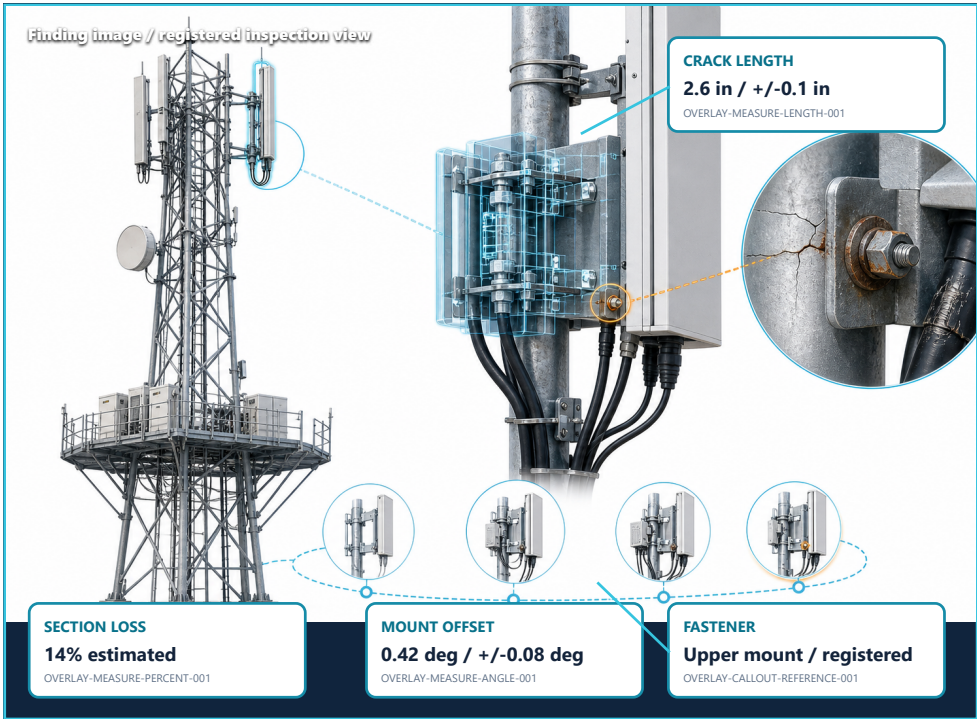
RGB-ASR1004723-021

## Mount cracking and corrosion at upper fastener

Surface cracking and corrosion were identified around the upper Sector B antenna-mount fastener.

ASR-1004723 / Sector B / Upper mount

Complete a qualified tower inspection, verify fastener torque, and obtain mount structural review.
