# Turbine WTG-17 - Blade B

Data Capture & Analysis Report

DW-RPT-WND-2026-0017

## Blade surface crack with correlated thermal indication

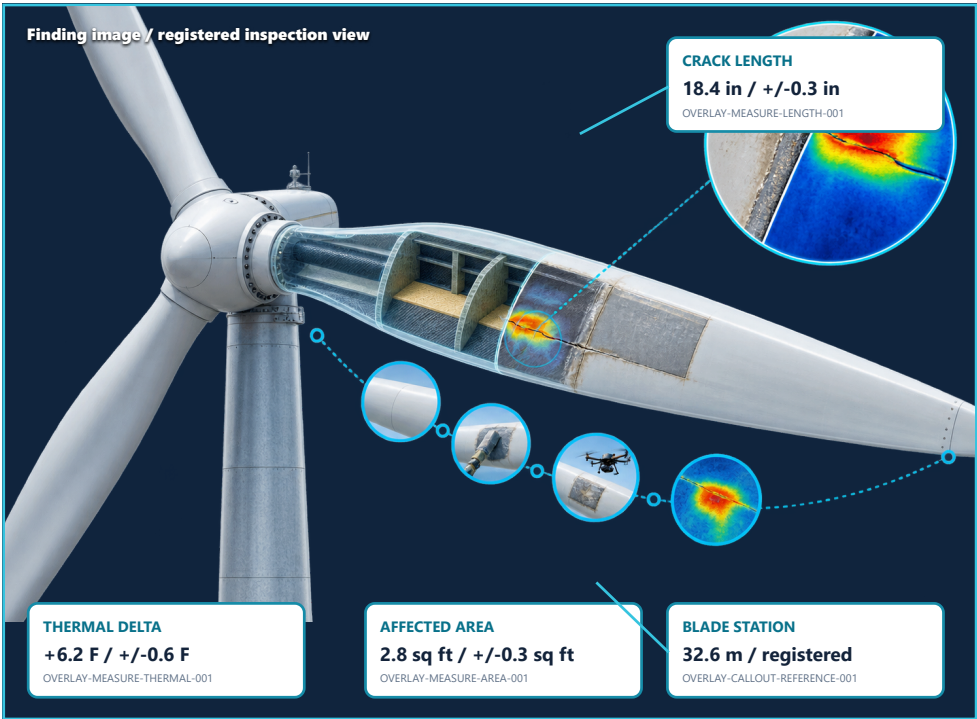
RGB-W17-118 / IR-W17-042

A visible blade crack and localized thermal response were identified near the spar-cap transition on Blade B.

Engineering Review Required

P1 - High

Complete a close-range blade inspection, repeat controlled thermal capture, and obtain composite engineering review.
