# Red Mesa - Array 7

Data Capture & Analysis Report

DW-RPT-SLR-2026-0023

## Persistent module hotspot across adjacent cells

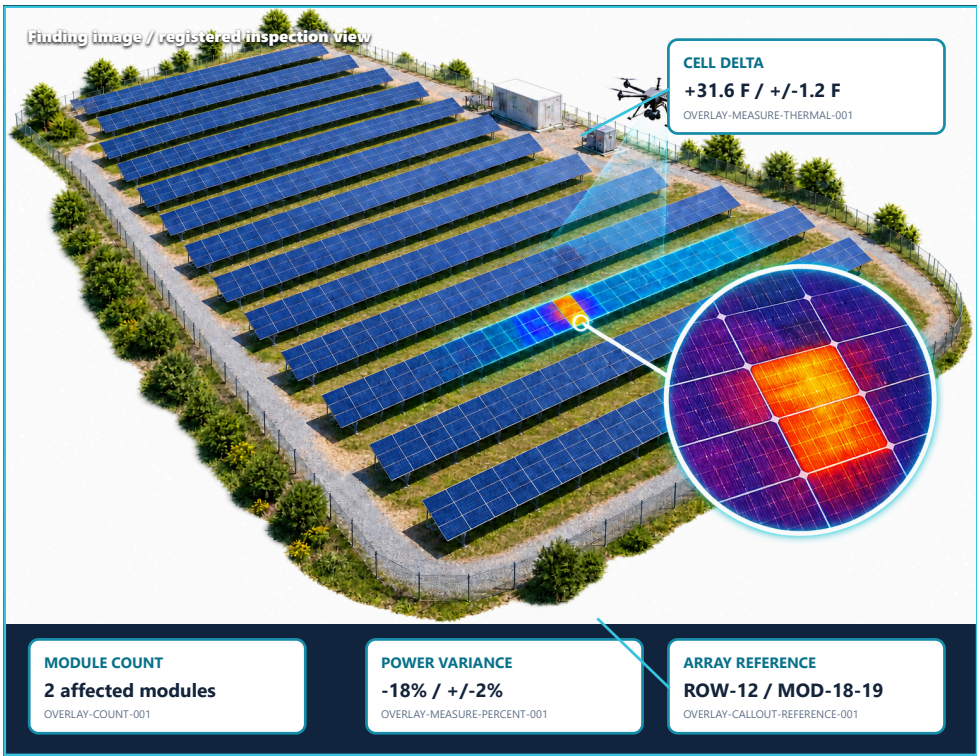
A repeatable thermal hotspot was detected across two adjacent modules with correlated electrical underperformance.

Array 7 / Row 12 / Modules 18-19

IR-RM7-044 / IV-RM7-012

Verify connectors and bypass diodes, perform I-V testing, and isolate or replace affected modules as qualified review determines.
